ASBESTOS INSPECTION REPORT FOR TAYLOR HALL

TAYLOR HALL

Montana State University Bozeman, Montana

DATE OF INSPECTION: 04/23/13

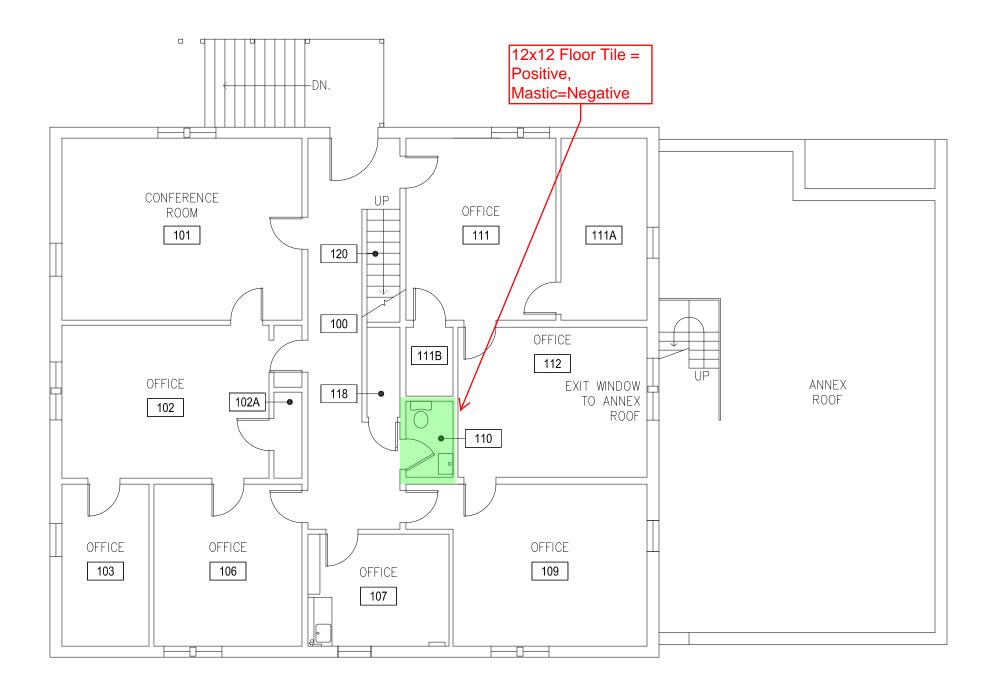
FLOOR PLANS
